## Colome School District 20-year-old EPDM Restoration

**Colome School District**  
**Colome Elementary School**  
**Colome, SD**

**Completion - 2021**

**System - Gaco's Flex System – SP-S20-38-20**

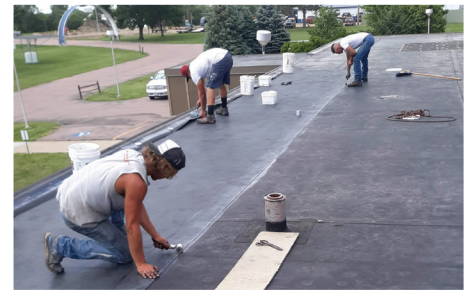
Repair EPDM saturated/delaminated areas

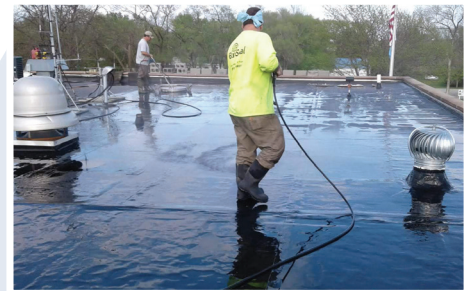
Wash EPDM

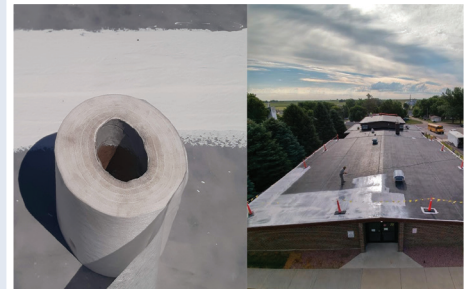
Apply 2 part epoxy primer, then reinforce seams and details using polyester mesh

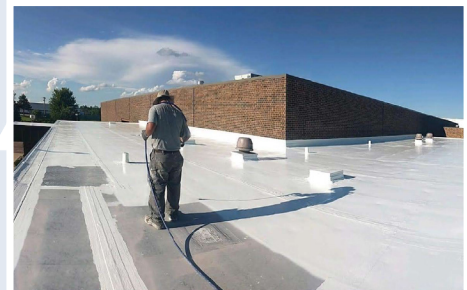
100% Silicone Top coat application

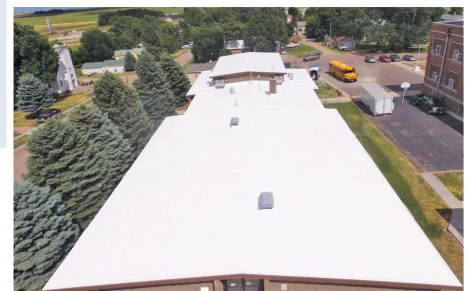
The finished roof
