FREEMAN SHOPPING CENTER

The new SPF & Coated System

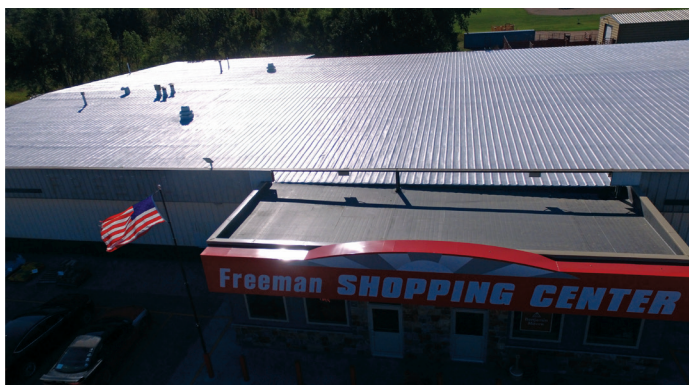
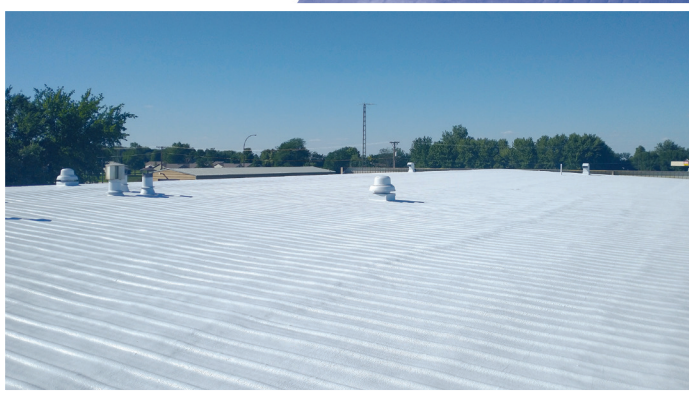
The Freeman Shopping Center's 43 year old facility was experiencing problems that are common for a metal panel roof of its age:

1. The owner was starting to "chase leaks" all too often because of the aging edge detail, fasteners, and seams.
2. The underside of the roof would condensate, drip, and then stain the ceiling tile when there was a warm up in the outside temperatures after a cold blast.
3. The closure strips at the roof edge were no longer filling the flutes, which allowed water to back up into the interior of the building.
4. The galvanized coating, the panels only rust protection, was wearing thin and was heavily oxidized with some minimal rust showing in places.
