A-1 ROOFING & INSULATION SYSTEMS

METAL ROOF RESTORATION

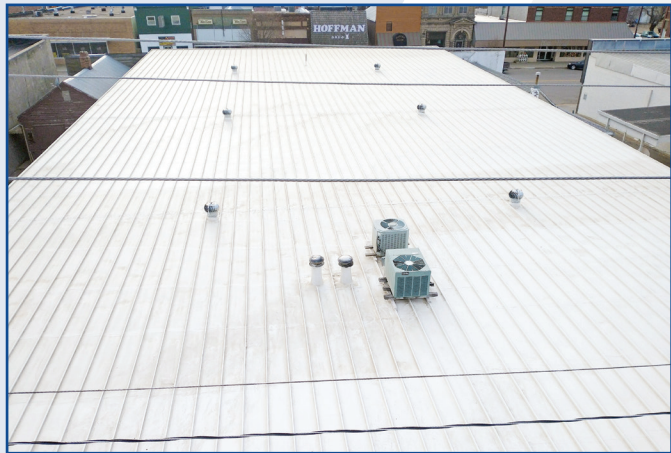
This standing seam metal roof had random leaks throughout the entire roof. The roof also had light surface rust in a few areas. The business owner did not want his business to be disturbed with an intrusive re-roof. We were able to fix his problems with a Full fluid coating and mesh system. His roof now has a 20 year factory inspected leak free warranty.

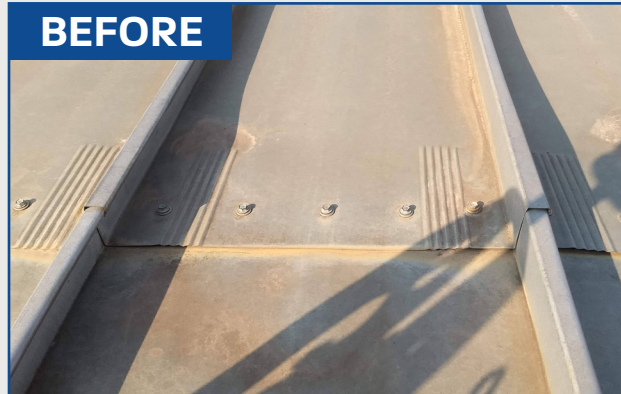
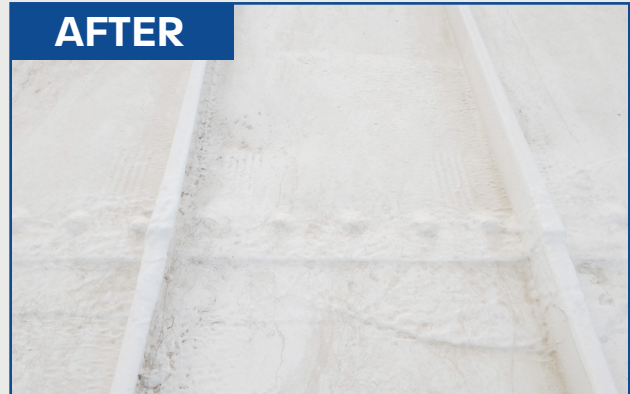
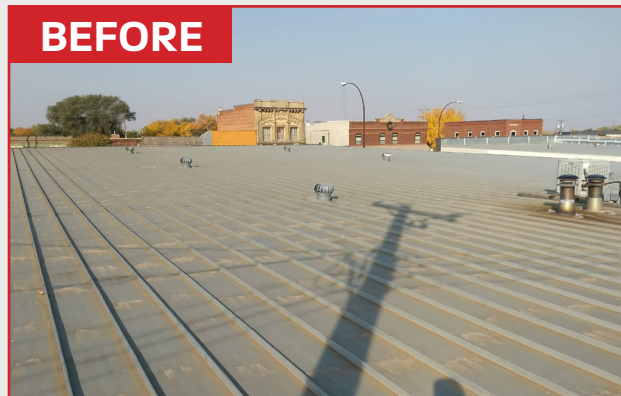
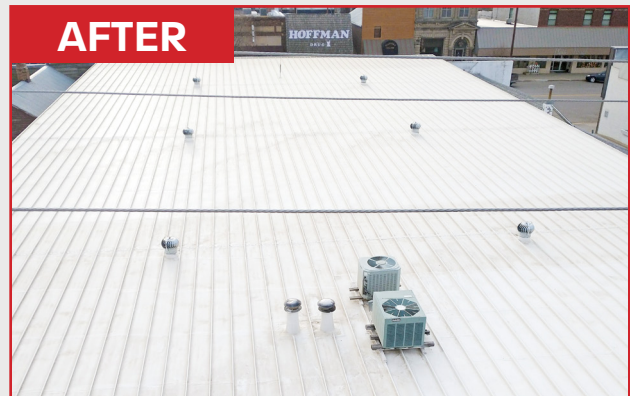
How it's done

- 1st:** Clean the dirt and oxidation off the roof with high pressure power washers.
- 2nd:** Prime the roof with two-part epoxy primer to ensure maximum adhesion
- 3rd:** Embedded Polyester Mesh is applied over any seams to make sure roof movement does not create cracks in the seamless system.
- 4th:** Screws and bolts are tightened or replaced and then covered with 100% solids Liquid Mastic.
- 5th:** Coatings are then applied to the entire roof surface to give the whole roof a seamless seal
